UNITED STATES
DEPARTMENT OF THE INTERIOR
BUREAU OF MINES

From: J. T. Whalen, Federal Coal-Mine Inspector, and J. L. Gilley,
Mining Health and Safety Engineer

Subject: Report on Investigation of Minor Coal-Mine Bump, No. 9 mine,
Jewell Eagle Coal Company, Melville, Logan County, West Virginia,
August 18, 1959

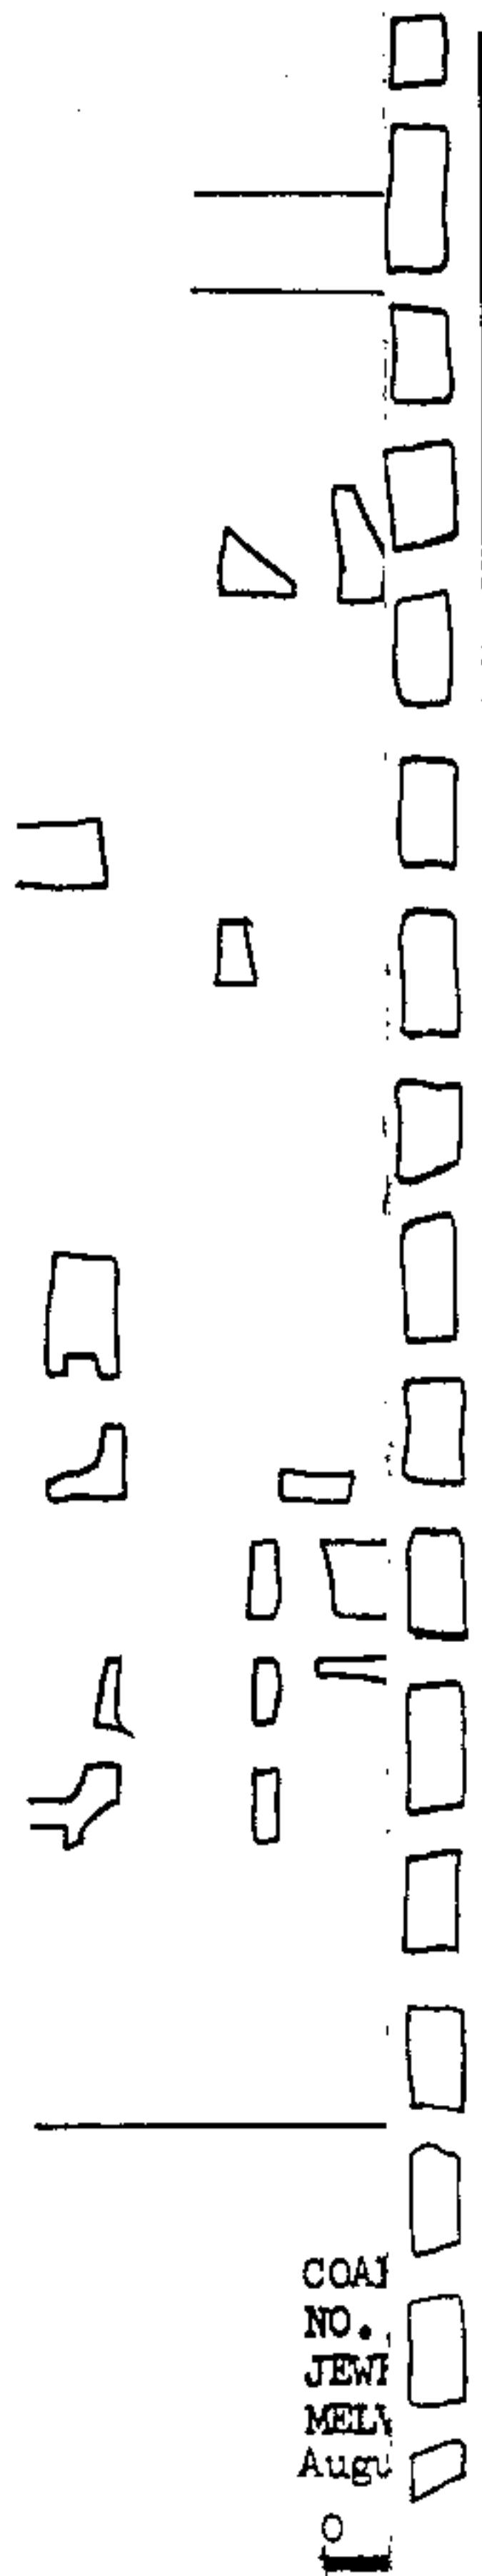
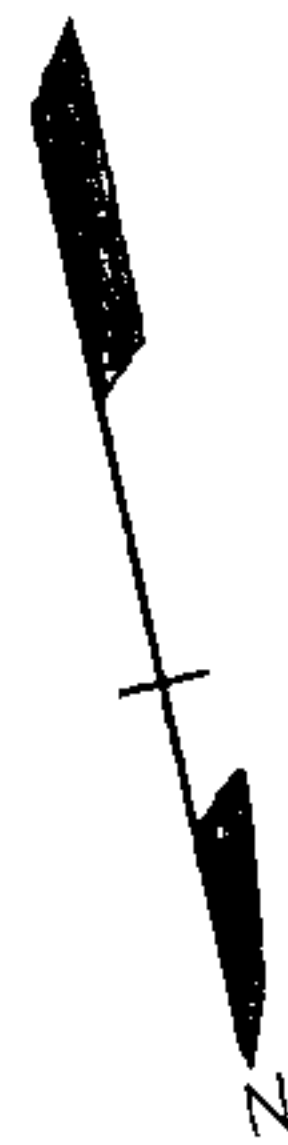
COAL-MINE BUMP
 NO. 9 MINE
 JEWELL EAGLE COAL COMPANY
 MELVILLE, LOGAN COUNTY, WEST VIRGINIA
 August 18, 1959 SKETCH 1

From Sketch 1 it will be further noted that pillar recovery had started in Nos. 2, 3, and 5 rooms although the No. 1 room which was in the most critical area lacked 22 feet or more being completed at the time the bump occurred, consequently, the extraction of some of the pillars was started out of proper sequence. From Sketch 2 it will be noted that coal pillars and remnants of pillars of various dimensions were left unmined in by the active working area, and, reportedly, coal pillars of varying dimensions were left unmined in the 2 butt left gob area. These unmined pillars and pillar remnants probably delayed and/or prevented the massive roof from caving as it should, thus likely imposing additional stress on the newly developed room pillars in the area involved.

it was learned during this investigation that a bump occurred while the loading machine was operating at the face of the No. 1 room with sufficient force to throw 3 or 4 tons of coal from the adjacent ribs. After this bump, the loading-machine operator trammed the machine back to the last inby open crosscut in No. 1 room and waited until the section foreman examined the place. The foreman stated that he did not discover anything unusual and instructed the loading-machine operator to load the loose coal thrown out into the roadway and finish loading the coal in the face. After the place was cleaned up, the loading machine was trammed into No. 5 room and had reached the location indicated in Sketch 1 when the bump occurred that injured the 2 workmen working in No. 3 room.
